## Extending the Dynamic Model of Situated Cognition to Submarine Command and Control

### ABSTRACT

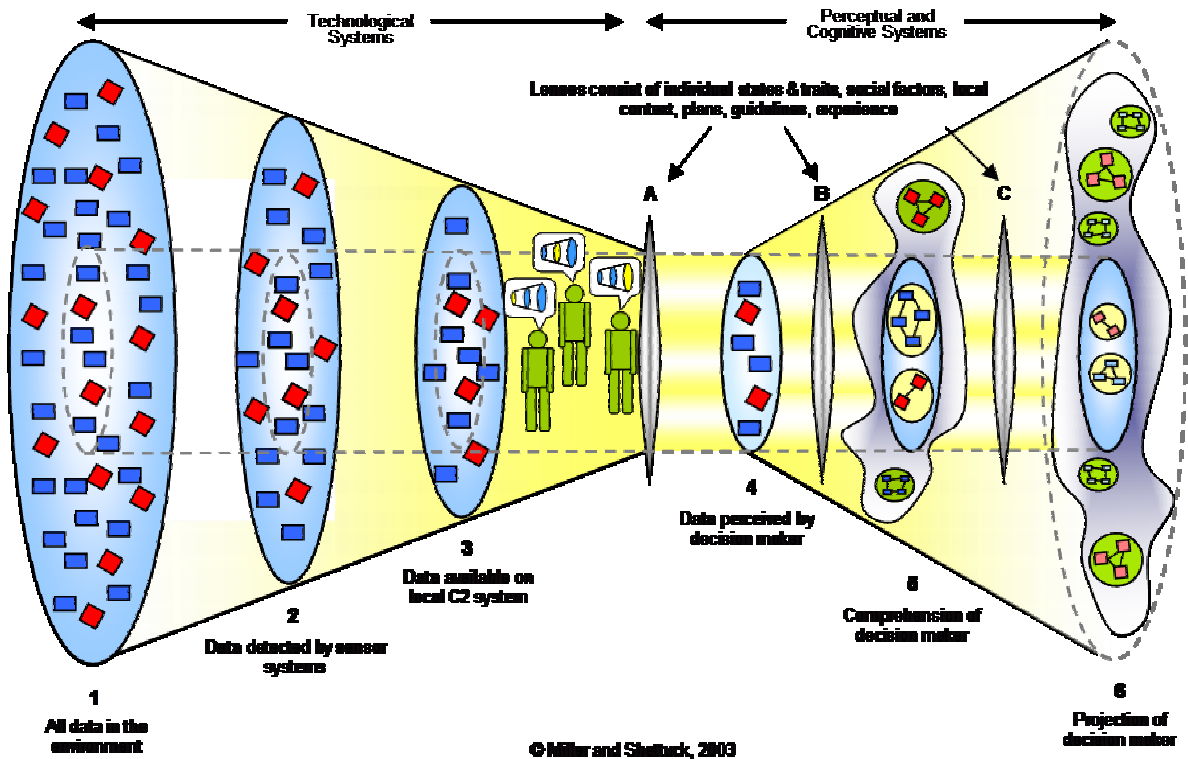
The DMSC posits that there are various stages of technological and cognitive system performance (see Figure 1). On the technological side, all the data in the environment, data detected by technological systems (e.g., sensors), and data available on local command and control systems (C2; e.g., workstations) are included. Each of these stages includes a subset of what was included in the preceding stage. Building upon this technology

FIGURE 1. Dynamic Model of Situated Cognition

The large oval on the left side of Figure 1 (Oval 1) depicts ground truth, (i.e., everything in the world). Ground truth is dynamic in nature, changing with spatial and temporal progression although it may be captured at points in time.

There is no error or uncertainty inherent in Oval 1. Simulations allow for the accurate representation of ground truth. In the real world, however, it is understood that Oval 1 cannot be measured with total precision and accuracy. The blue rectangles and red diamonds in Oval 1 represent individual data elements for friendly and enemy entities. While other things are present in the world (e.g., noncombatants, weather, terrain, friendly and enemy intent), they have been excluded from the figure for simplification.

The next oval (Oval 2) shows the elements detected by the technological portion of the system. Note that this oval is depicted as a subset of the first oval. However, it is not apparent what portions of ground truth are being detected and what items remain undetected. Error or uncertainty can first enter the model at Oval 2, taking various forms. Oval 2 is a subset of Oval 1 for a variety of reasons.

Oval 3 depicts what is displayed on the decision maker's workstation. These data are a subset of what is represented in Oval 2. Users are able to tailor their displays to suit their individual preferences. If the user has the display settings adjusted on the C2 screens such that information is not displayed, it is possible that important, perhaps vital, information may be hidden or concealed. It may not be obvious to the user which data have been excluded. Oval 3 represents yet another entry point for error or uncertainty into the model.

The technological aspect feeds into the perceptual and cognitive aspects of the DMSC. On right side of the model, three lenses are depicted (see Figure 1). Each individual has a unique lens. The lens is continually updated and is present at three points in the model (see A, B, and C in Figure 1) to focus the decision maker, to reflect the unique perspective of the decision maker, and to provide context. In a military context, the lenses are comprised of the following information and attributes: experience (societal, cultural and individual), states or performance characteristics (system/team and individual), specific plans (micro level - the temporal context in the days and hours preceding the incident), and rules of engagement or doctrine (macro level - the temporal context in the months preceding the incident). Together, these classes of information influence what is perceived by the user or decision maker.

Oval 4 represents all the data actually perceived by the decision maker, contains only a portion of the data available in previous ovals and may

Perceived data are of little value to the decision maker until they are processed. The same lens components that directed attention and led to perception also influence comprehension. The friendly and enemy icons in Oval 5 have been linked and reorganized, suggesting that they have been processed, represent the comprehension of the data elements that were perceived. The oval is embedded in an amorphous shape, suggesting that there are other possible ways the data could be linked and reorganized that would lead to alternative mental representations (e.g., situational models) of the data.

The final oval (Oval 6) represents the decision maker's projection into the future or his prediction. Alternate views of the battlefield within the amorphous shape but outside of Oval 5 do not contribute to or influence the prediction of the decision maker. Note that the amorphous shape that surrounds Oval 6 is larger than that which surrounds Oval 5 and contains even more alternatives. This representation depicts the idea that there is much greater uncertainty associated with prediction.

Description of the DMSC thus far implies that processing occurs in a linear fashion from the technological side to the perceptual and cognitive side. However, there are feedback loops within the model (not shown in Figure 1). For example, a projection (Oval 6) can lead the decision maker to modify sensor coverage (Oval 2) or a local C2 display (Oval 3), influence perception of data (Oval 4), or influence comprehension of data (Oval 5). Moreover, both projection (Oval 6) and comprehension (Oval 5) can shape the contents and contours of the decision maker's lenses (A, B, and C).
